# Manhole Inspection Summary

Manhole # S29E\_\_034MH

**Inspection** ☐ Is Incomplete Rating: **3) Fair**

**Location** Address: **680 N Pine St**

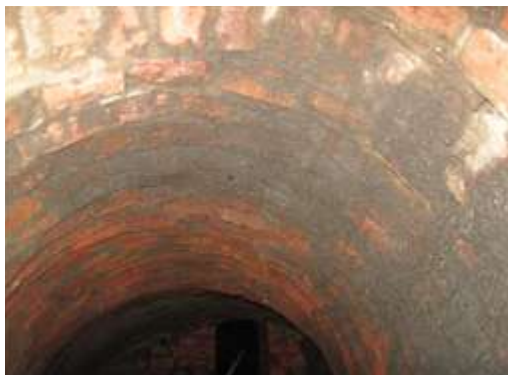
Miscellaneous

do to the construction of the manhole  
unable to get a persice measurment with  
bar and rod (pic in misc) pipe 7 oclk

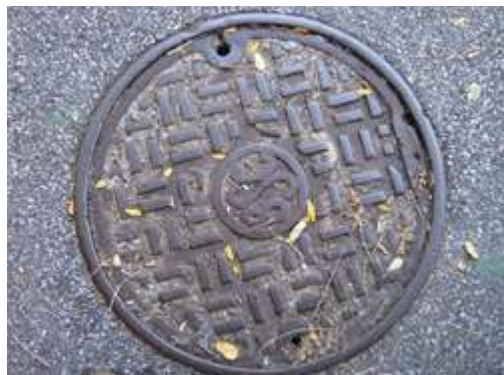
Miscellaneous

cover pic

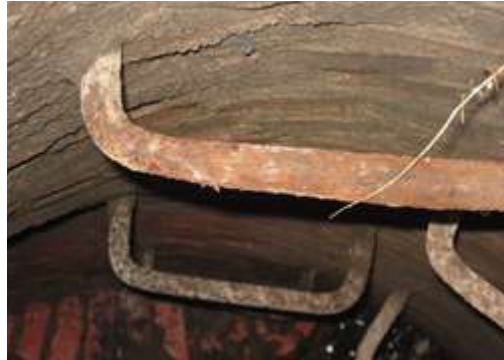
Defect 6

Count: **5** Missing: **0** ☒ **Corroded**

highly oxidized rung

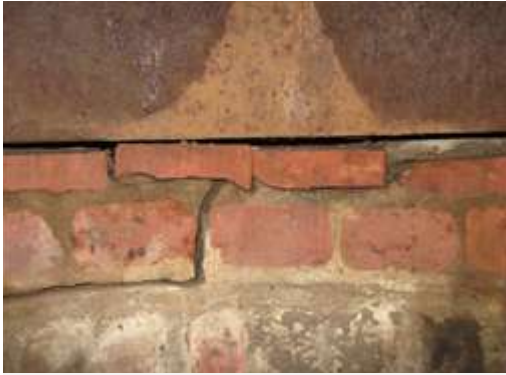
Defect 5

Condition: ☐ Sound ☒ **Cracked** ☐ Root Intrusion ☐ Loose Brick ☐ Deteriorated

chimney is cracked with loose brick

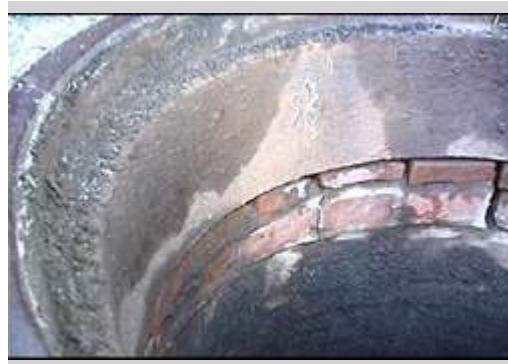
Defect 3

Condition: ☐ Sound ☐ Cracked ☒ **Leaks**

Infiltration: ☐ None ☒ **Joint** ☐ Cracks ☐ Mortar ☐ Roots ☐ Wall

frame leaks, infiltration from chimney joint

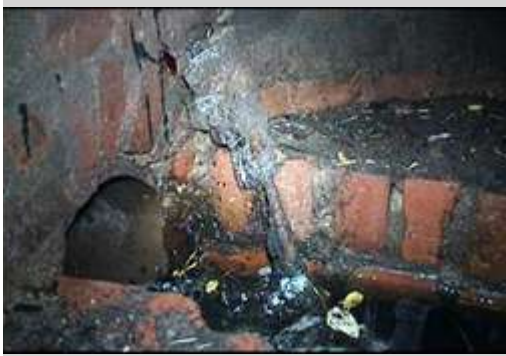
Defect 2

Condition: ☐ Sound ☐ Cracked ☐ Root Intrusion ☐ Deteriorated ☐ Leaks ☒ **Debris**

debris in channel

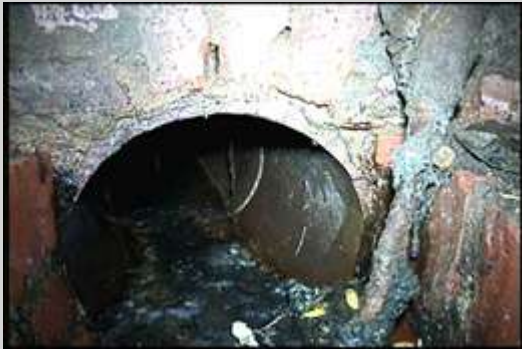
12 O'Clock Outflow

Pipe Height: **10.8** (in.) Rod and Bar (Angled)  
Pipe Material: **Clay** ☐ Pipe Lined  
Invert Depth: **10.56** (ft.) Flow Characteristics: **Slow**  
Deposits: ☐ None ☒ **Mud** ☒ **Sludge** ☒ **Debris** ☐ Grease  
Silt Depth: **4** (in.) Deposits Extent: **Heavy**  
Infiltration: **None** Pipe Seal Cond: **Sound**

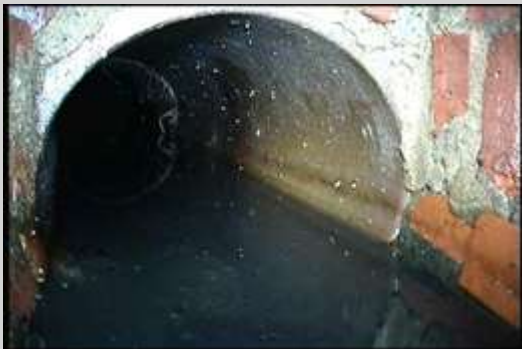
7 O'Clock Inflow

Pipe Height: **10.8** (in.) Rod and Bar (Angled)  
Pipe Material: **Clay** ☐ Pipe Lined  
Invert Depth: **10.82** (ft.) Flow Characteristics: **None**  
Deposits: ☐ None ☒ **Mud** ☒ **Sludge** ☐ Debris ☐ Grease  
Silt Depth: **3** (in.) Deposits Extent: **Medium**  
Infiltration: **None** Pipe Seal Cond: **Sound**
